Cedar Lake Engineering Feasibility Study

May 24, 2004

**Environmental Forensics Investigations, Inc.
Chicago, Illinois**

**Under the Sponsorship of
Indiana Department of Natural Resources
Lake and River Enhancement Program**

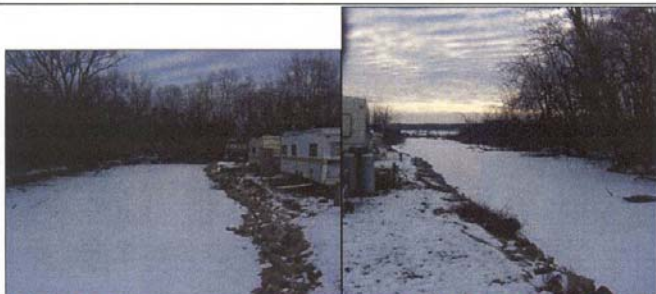
North Point Marina. Three small drainage ditches enter this dredged channel. Ditches drain residential area, gravel roads showing some sign of surface erosion. Seasonal trailers appear to be sewerred.

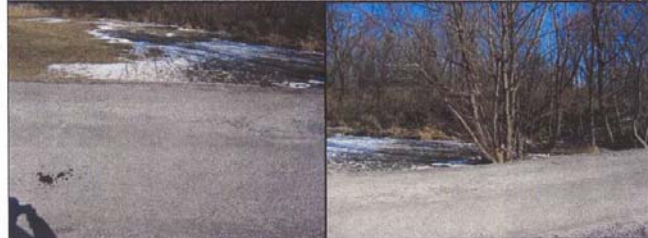
There is ponding in a lawn upstream of a culvert going under the RR embankment. This site may offer an opportunity for a detention-based BMP. Some streambank erosion along the channel downstream of culvert.

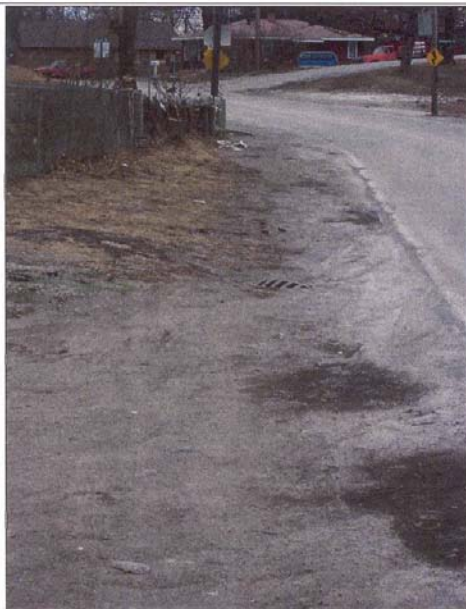
Many roadsides in Cedar Lake are sources of sediment, exemplified by this photo of a roadside storm drain that leads to the condos inlet.

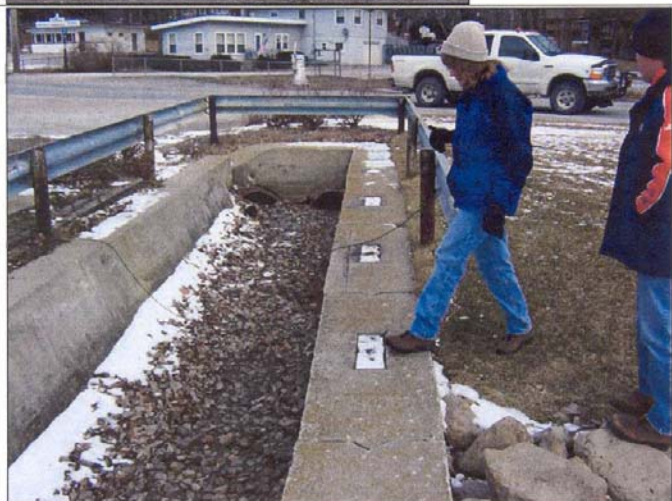
North inlet (adjacent to the Chamber of Commerce). Note clean gravel on the bed of this channel. Wetland north of road offers a potential location for project.

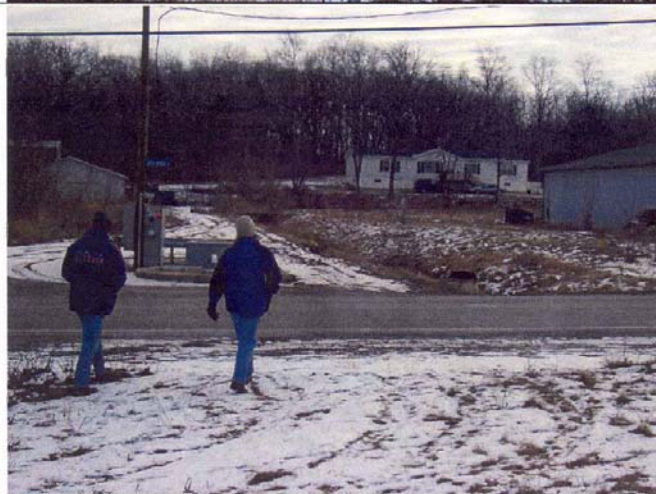
Channel leading to lake near the old bank building. Note potential site for a detention or filtration-based BMP project across Lakeshore Drive.

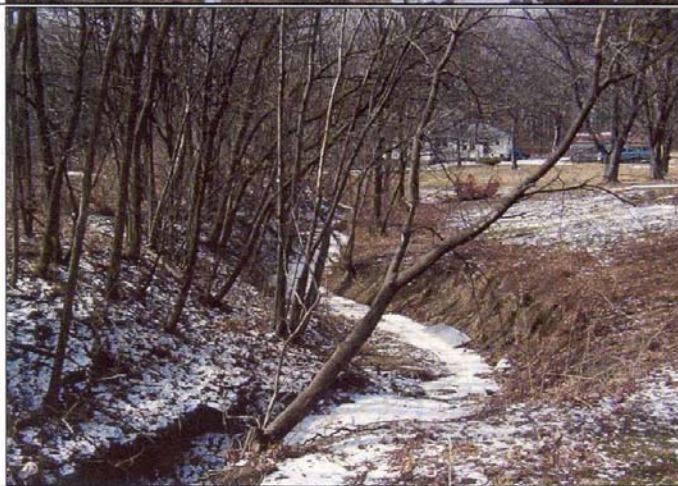
Upstream channels by 133rd Ave and Fairbanks St. show signs of downcutting/bank erosion.

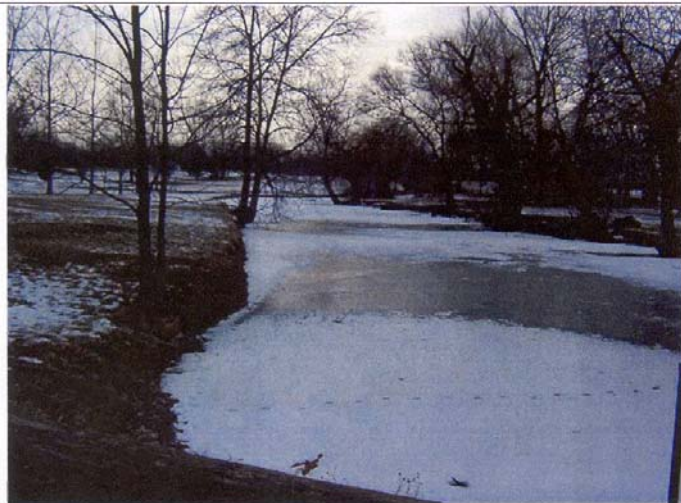
Golf course inlet. Note lack of vegetative or stone protection on banks.

Weir structure maintains water level.

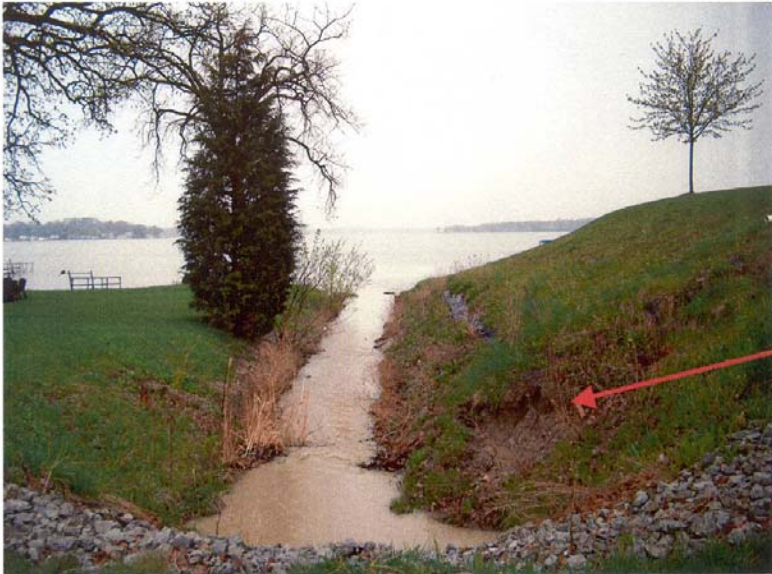
Figure 1: Condos Inlet

Note start
of failing
streambank

Appendix D Figure 1 shows the channel between the condos and a single-family residence where it discharges to Cedar Lake. Note the area of streambank that has started failing. This bank has failed since this picture was taken. The 100-foot open channel to the lake is narrow and the banks are very steep, rising as much as 20 feet above the stream. Significant earthwork would be required to create a detention-based BMP here. Disturbance to the banks and stream channel and the adjacent condominium and single-family properties would create unusual costs and this project was considered unfeasible and removed from further consideration.

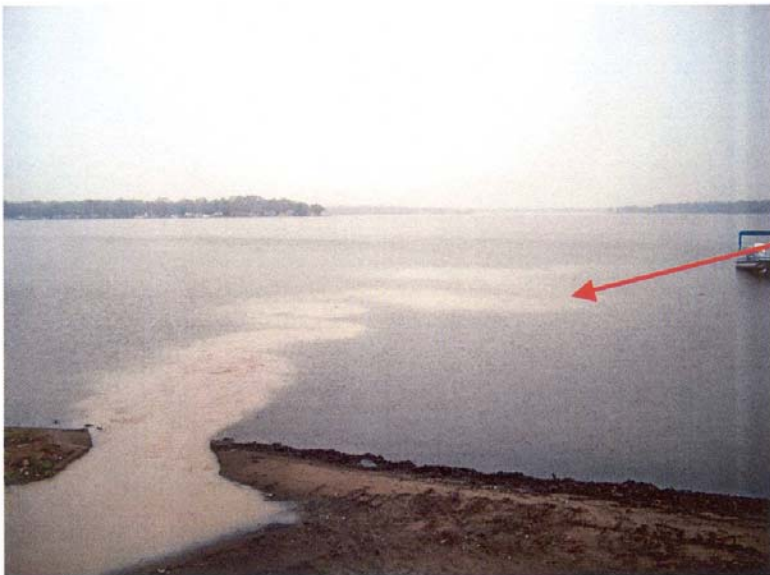
Figure 2: Turbid Water from Condos Inlet into Cedar Lake

Note
sediment
plume in
Cedar Lake

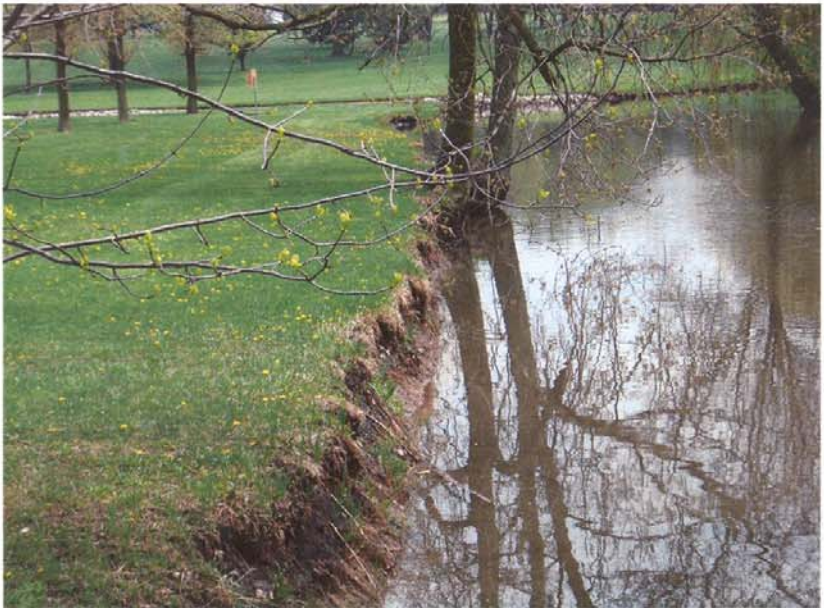
Figure 8: Failing Streambanks at Golf Course Inlet, North of 145th Avenue

Mr. Hayes also indicated that he was concerned with the bank stabilization of the stream and ponded areas. The fluctuation in water levels has caused many locations of the banks to slough into the channel and ponded areas. The South Shore Golf Course rip-rapped the banks in areas that were most severely eroding. Additional areas need stabilization. Discussions with Mr. Hayes indicate that he is amenable to additional streambank stabilization and that he would prefer rip-rap to match the areas already protected. Proposed improvement areas are shown in Figure 13 A conceptual design using rip-rap is shown in Figure 14. A modification of this design using erosion control blanket and seeding is also feasible although more maintenance would be likely.

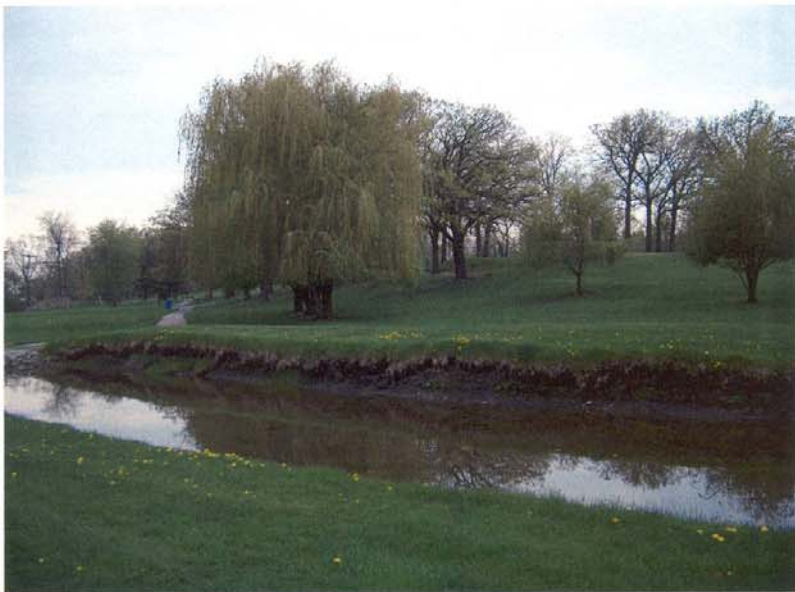
Figure 9: Failing Streambanks at Golf Course Inlet, South of 145th Avenue
